Service News

Trouble Case 1
“Why Exh. Gas High Temp. Alarm?”

Boiler Type : Steam Boiler VWH

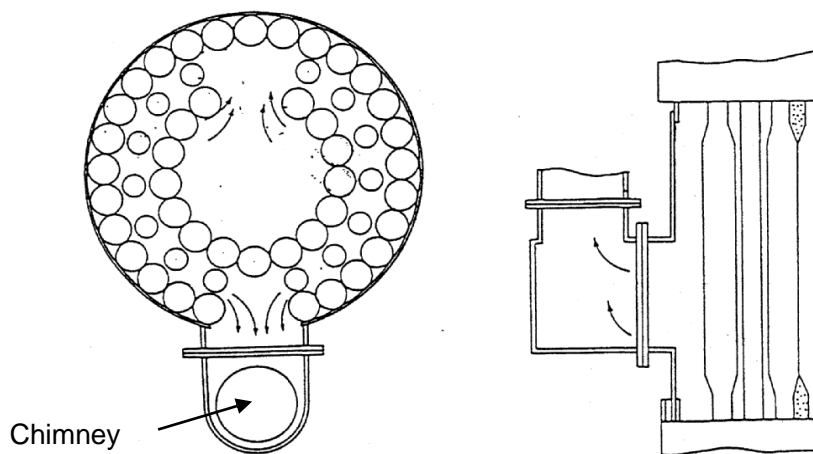
In this case, we suspect that the cause of the trouble is that the washing around the chimney stand has not been carried out completely or the soot which came off easily by washing • the incinerator inside soot which was not discharged outside were piled up on the chimney stand by combustion. If the combustion has been continued for a lone time under this condition, the soot might be built up on the flue gas passage by the incomplete combustion, moreover, it might cause the condition such as the combustion is impossible. We apt to judge that the soot is removed completely by washing at the dockyard, but do not forget the above mentioned weak point. A lot of soot is discharged at washing on the boiler combustion room side. **At this case, please remove the soot completely. The incomplete washing brings about the chamber inside clogged up, and the chamber pressure increase, and then incomplete combustion.**

The mechanism reaches the combustion impossibility after washing is the followings;

1. Washing
2. Soot accumulation on the part of the chimney
3. Chamber pressure increase at the combustion test
4. Incomplete combustion
5. Soot occurs and built-up
6. Chamber pressure increase more by soot built-up
7. Combustion inferior
8. Misfire
9. Combustion impossibility
