How to Prevent “UV Dose Lower” Alarm from Being Issued

To prevent “UV Dose Lower” alarm from being issued in our ballast water management system, we would like to provide you with some useful information.

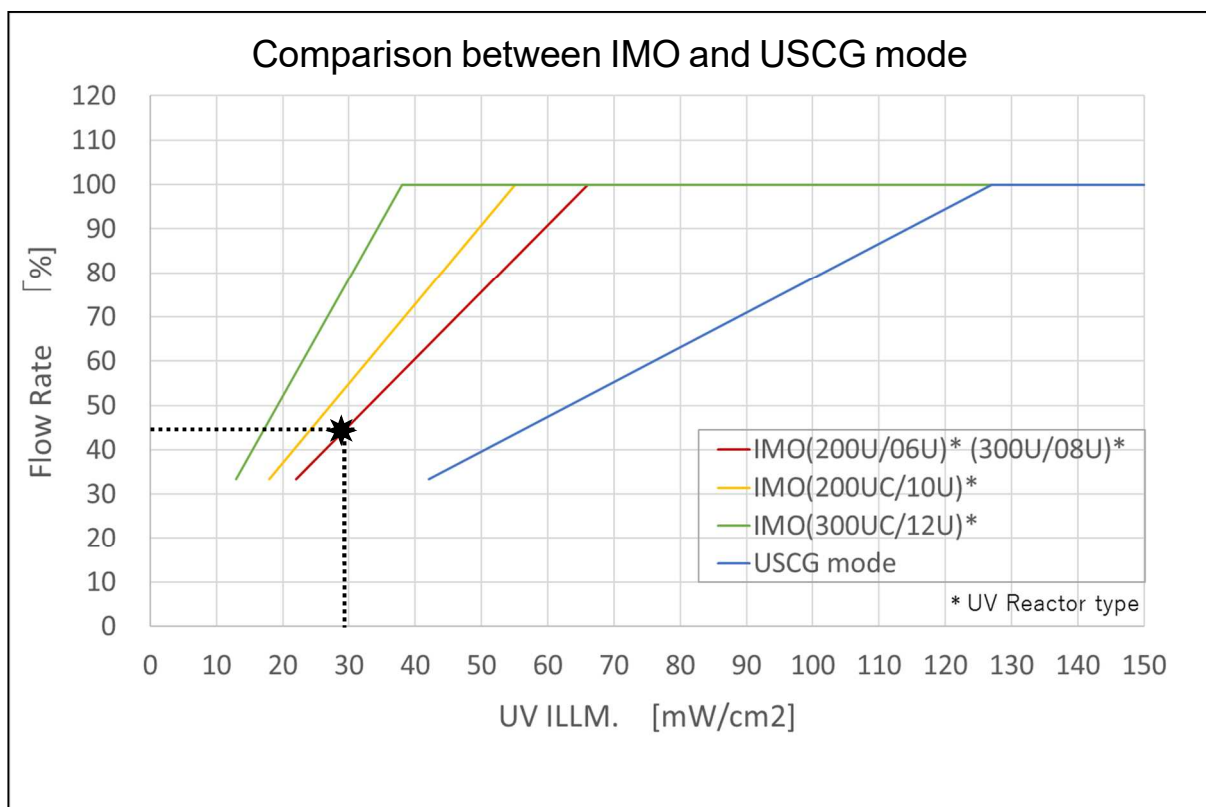
How to read the graph (Example: IMO (300U/08U) *Red line in the graph)

When the UV ILLM. (UV illuminance) is 30 mW/cm², the Flow Rate should be adjusted to approximately 45% to prevent the "UV Dose Lower" alarm from being issued.
